Phase II Environmental Site Assessment & Limited Subsurface Investigation Report

AEH Project #: OTM615A
November 5, 2015

Old Town Newhall Mixed Use Project

City Block Bounded by: Lyons Avenue / Railroad Avenue / 9th Street / Main Street
Newhall, California 91321

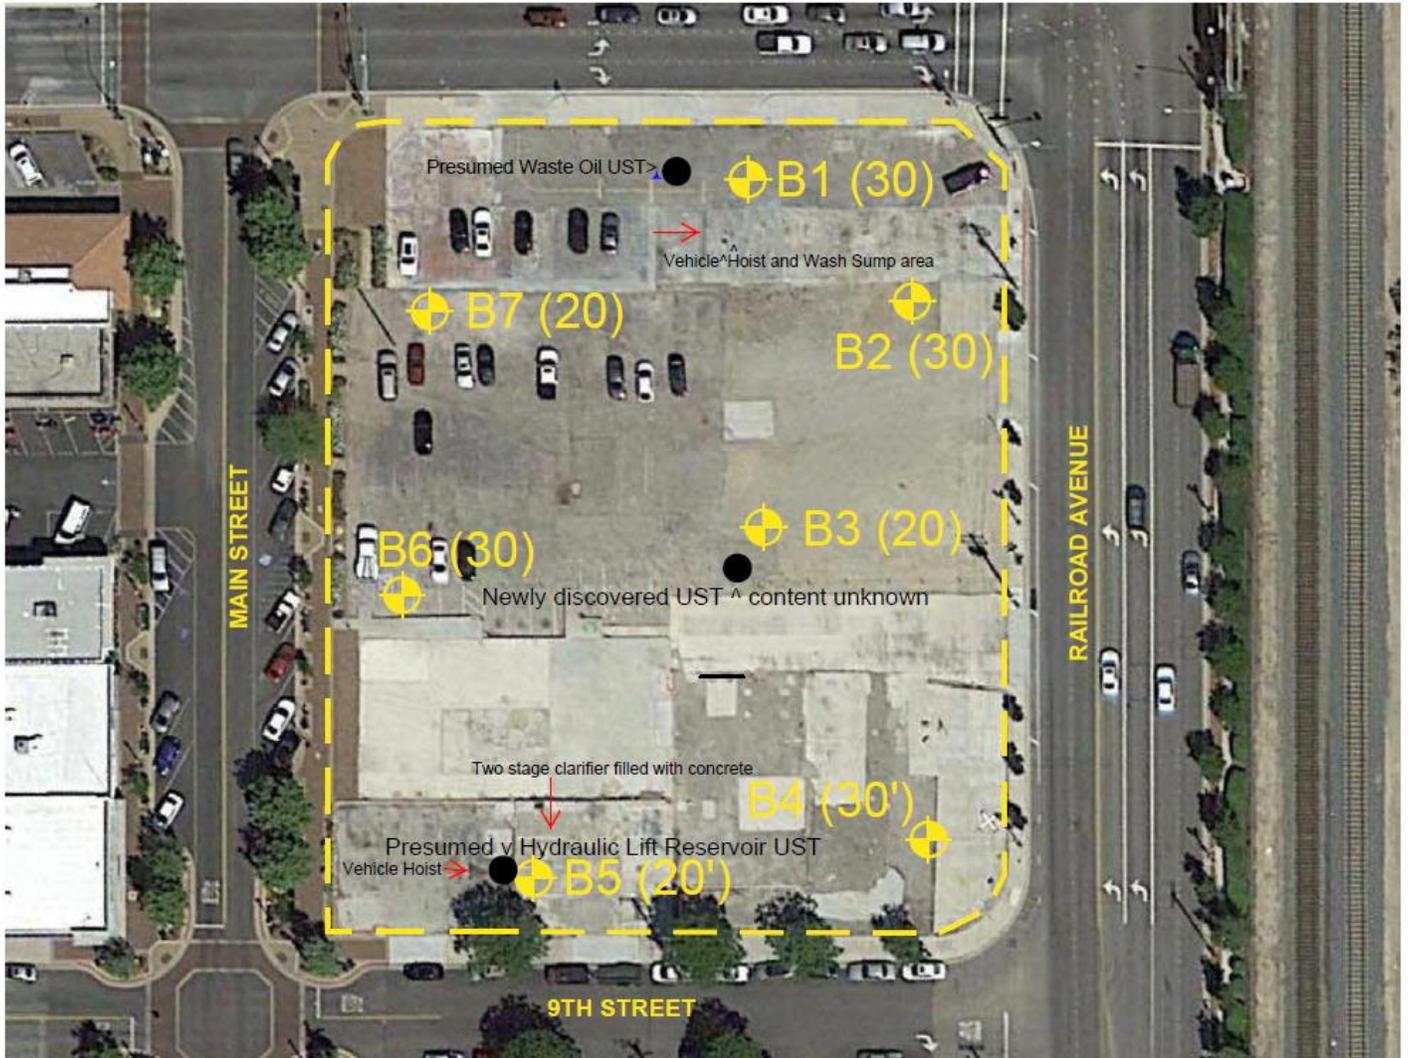
Figure 1 – Site Map with Sampling Locations

Seven (7) soil sample points were located across the entire property. Boring locations were selected to enable geotechnical soil characterization across the site. A limited subsurface environmental investigation occurred concurrently. These samples were extracted utilizing a hollow stem auger. This sampling technique enables appropriate geotechnical evaluation while at the same time affording the environmental investigator a limited opportunity to establish whether pervasive subsurface impact has occurred or significant *recognized environmental conditions* exist. It can also begin the process of identifying vertical and lateral extent of migration of contaminants, if appropriate. These sample points were distributed throughout the property.

LOCATION OF PROPOSED BORING

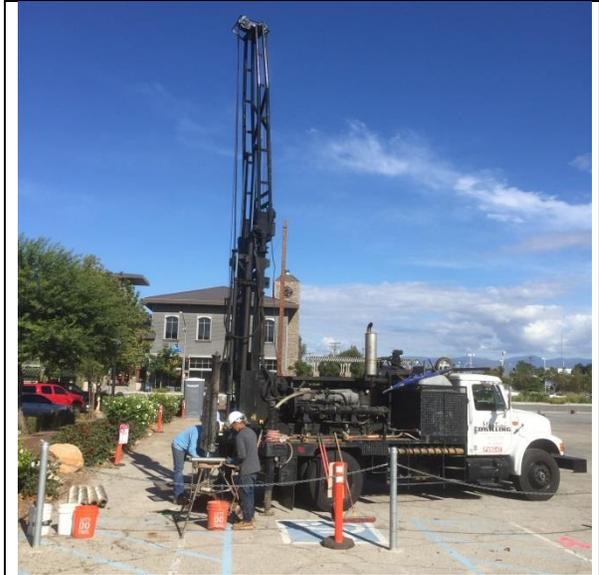
Auger rig advancing boring B6

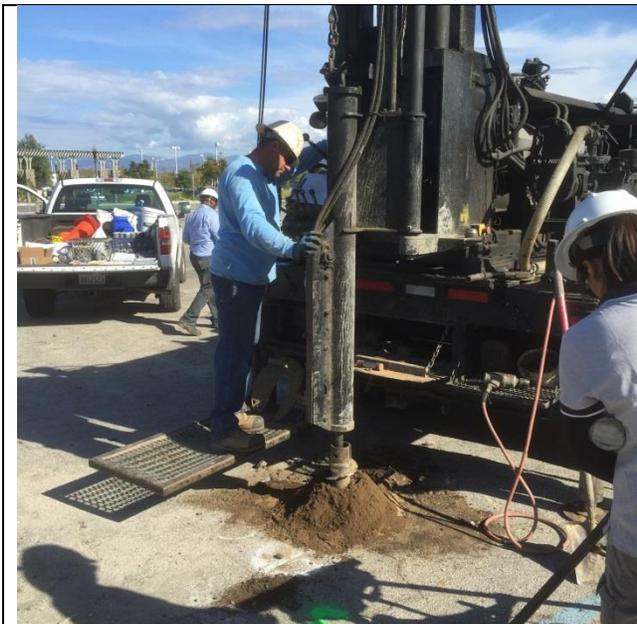
Advancing geotechnical / environmental soil boring

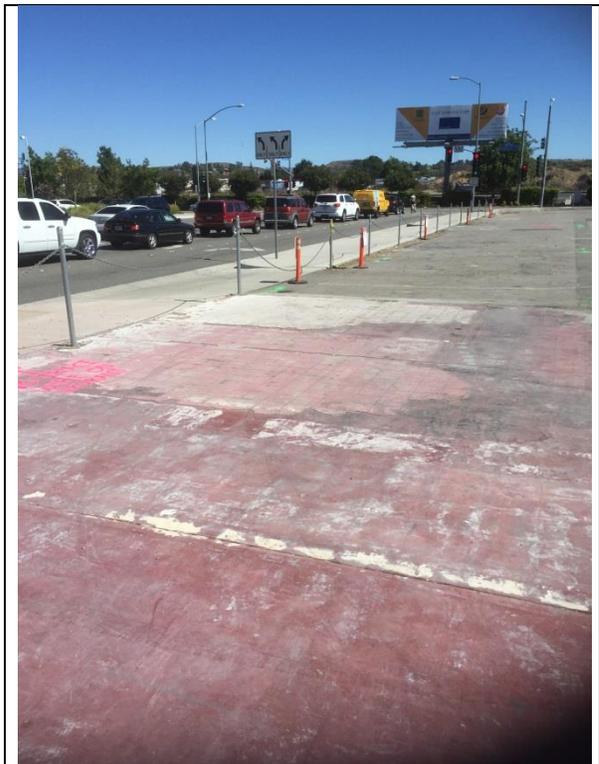
Vinyl Asbestos Floor Tile This *recognized environmental condition* is about 250 square feet including two layers of vinyl asbestos floor tile will need to be removed or abated prior to slab removal and subsequent surface disturbance.

Vinyl asbestos floor tile (requiring abatement)

The fifth area containing a *recognized environmental condition* is the extreme northwestern corner of the property where a vinyl asbestos floor tile abatement project should be performed. The aerial extent of this tile is estimated at 250 square feet and a containment can be built around and over this area to abate the tile properly. Because most of this tile was removed (disturbed) during building demolition, the South Coast Air Quality Management District (SCAQMD) may demand this formal asbestos abatement project work be performed only after development and acceptance of a Procedure 5 workplan.
